# **Intellispect, LLC**

## **Property Inspection Report**

123 Sample Dr, Town, CT 06xxx  
Inspection prepared for: Firstname Lastname  
Date of Inspection: 10/5/2018 Time: 9am  
Age of Home: Built 1978 Size: 2357 sq ft  
Sample Report

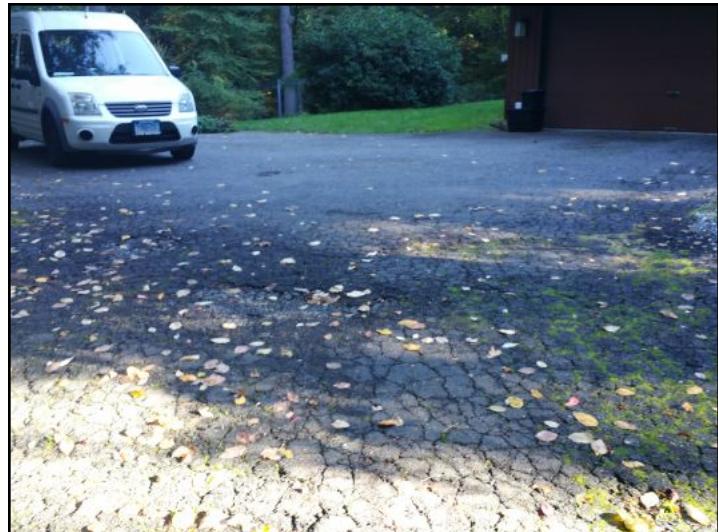
- Asphalt driveway noted.
- Moderate cracks and heaving noted. Repair and/or monitor for expansion and development of trip hazards.
- Minor settlement, or "hairline" cracks in driveways are normal for properties of any age. Periodic monitoring for expansion and sealing as necessary will reduce safety hazards and prolong its life.

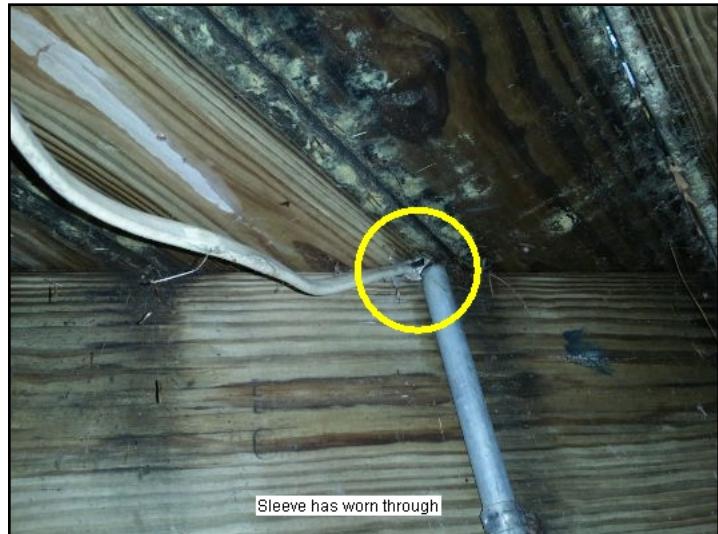
- Exterior conductors under the back deck are not protected by a conduit. One of the electrical cables has worn through its protective sleeve. This is a shock hazard. All exterior wiring should be secured to the home and/or inside an approved conduit. Recommend further evaluation and repair by a qualified electrician.

Sleeve has worn through

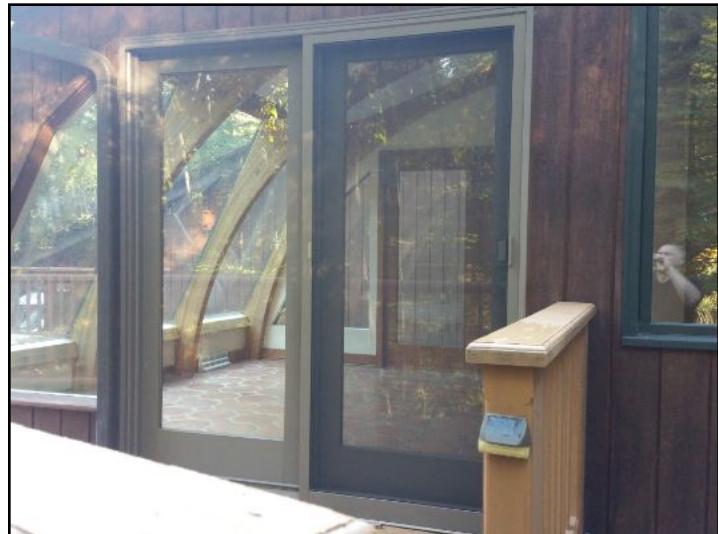
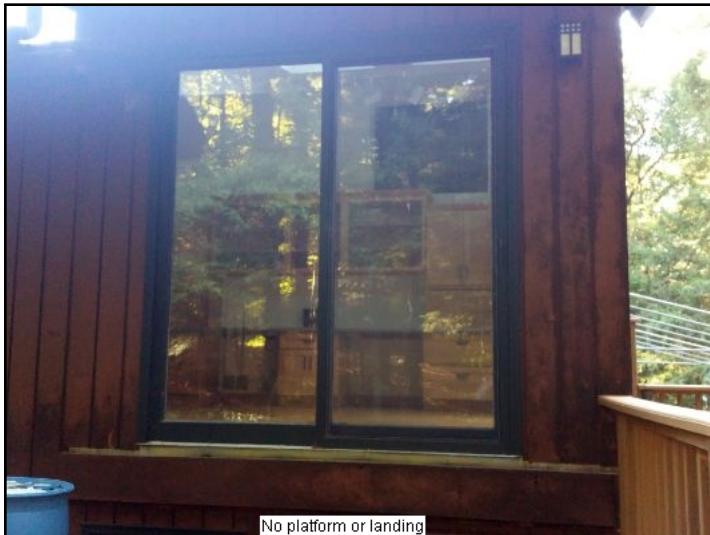
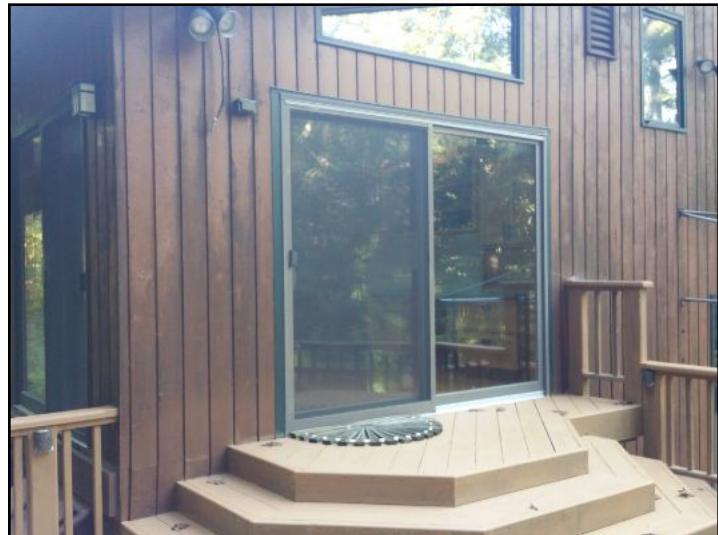
- Exterior doors noted in front of the garage, at the front deck (2), on the east side, and at the back deck.
- Appeared in functional and in satisfactory condition at time of inspection with no major deficiencies noted except for the following:
  - Doorbell tested and functioning at the time of inspection.
  - **Exterior door on the east is at an unsafe level above grade. This condition may cause someone to get hurt if they fall out of the doorway. Recommend installing a platform for safety or rendering this door unusable.**

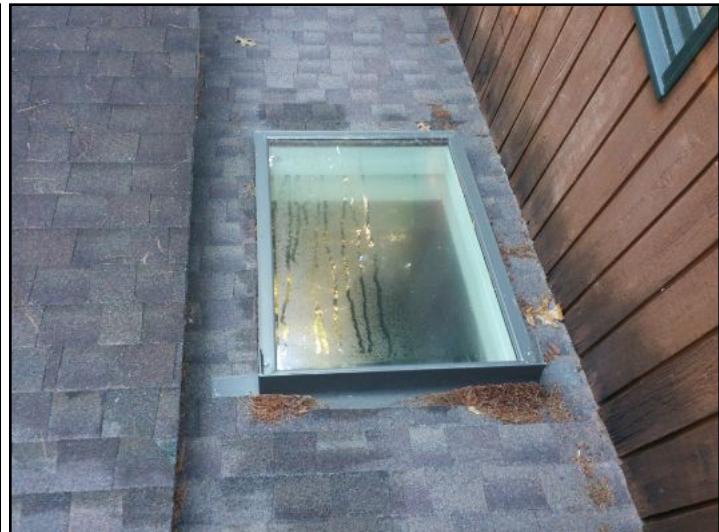
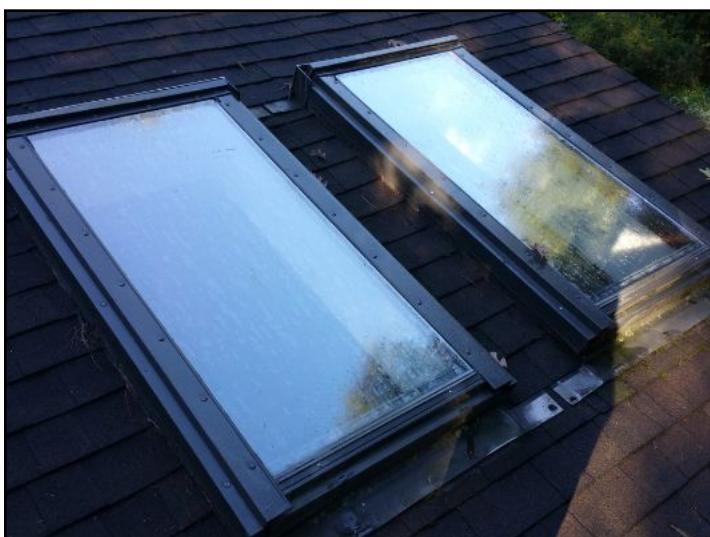
- Skylights noted above the main entryway and on the east facing roof plane (x2).
- Recommend clearing the area above the entryway skylight free of debris.
- Fastener heads are visible at the flashing at both east side skylights. Recommend sealing over the top of all fasteners that penetrate through the roof to prevent moisture intrusion.
- The two skylights on the east side have water stains at the corners that tested positive for moisture content, indicating leaks. Recommend further evaluation and repair or replacement of the skylight flashing as necessary by a qualified roofing contractor.

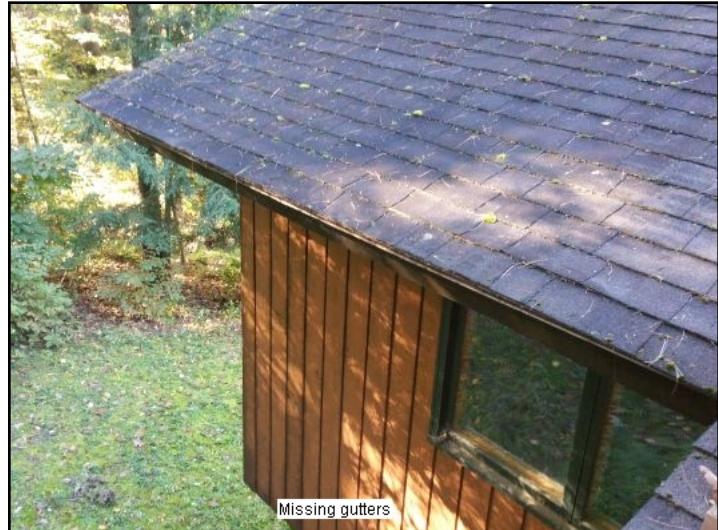
- Metal gutters noted.
- Gutter guards noted.
- While most gutter guards are excellent at preventing full sized leaves from clogging gutters, they seldom provide foolproof protection against buds and small debris. Your gutters may still need to be cleaned periodically.
- Gutters properly sloped toward the downspouts.
- Some downspouts discharge to an underground drainage system which could not be evaluated. See Limitations section.
- There are no gutters at the front entryway and at the southeast corner. Recommend full installation to keep water away from the structure. Water that is discharged next to the foundation can cause moisture issues in the home. Be sure to install splashblocks or extensions to carry water away, preferably at least 4 to 6 feet, and keep water from areas such as driveways or walks where it can be an ice hazard in winter.

Missing gutters

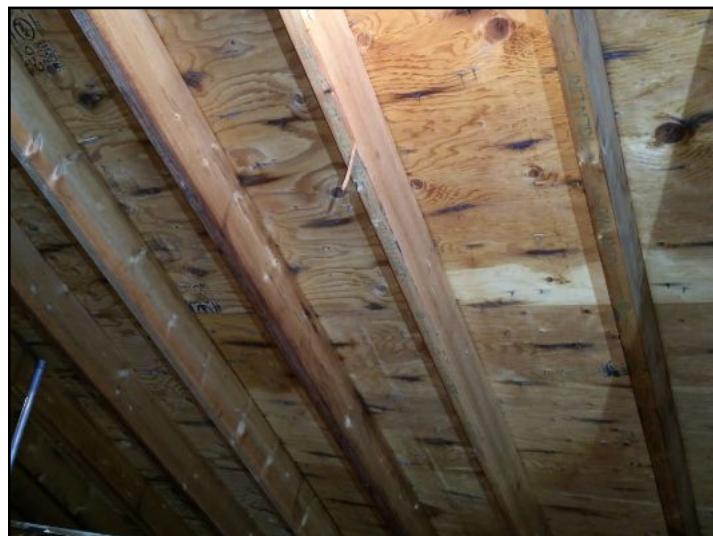
- Roofing nails visible (as they should be).
- Dark stains were noted on the sheathing around the roofing nails, which were badly rusted. This is an indication that moisture has gotten into the attic and condensed on the nails. Be advised that the roof is newer and it took a relatively short time for the rust and dark stains to form.

- Since there are indications of moisture buildup in the attic such a short time after the last roof installation I recommend routing the bathroom exhaust to the exterior and monitoring the area for worsening condition. If the problem persists, an insulation contractor should evaluate and seal any air leaks in the attic and also a roofing contractor evaluate to determine if there is enough ventilation.

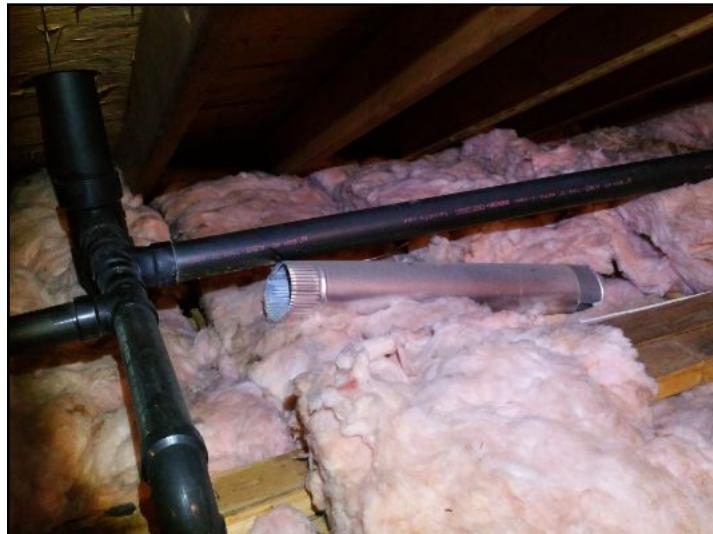
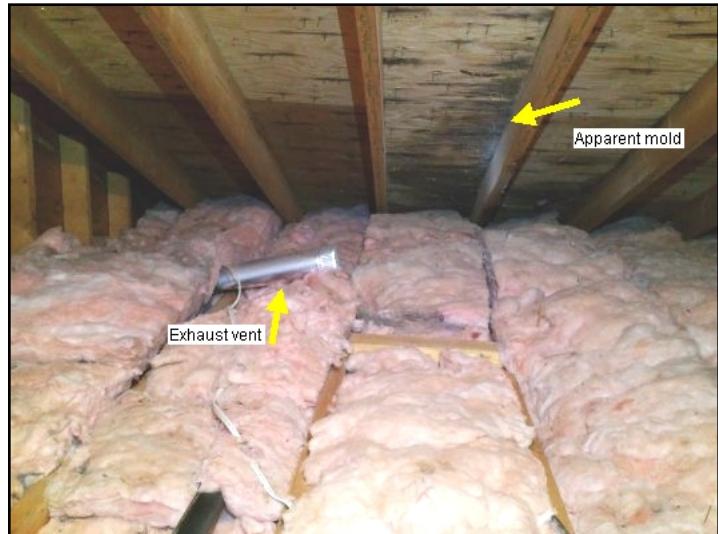
- Bathroom exhaust fan ducts terminate in the attic. This condition contributes excessive moisture into the attic space which may result in deterioration and/or mold. Recommend having the duct routed to the exterior to minimize moisture. A small section of what appears to be mold is forming near the master bathroom exhaust. You should consider having the substance tested and/or removed.

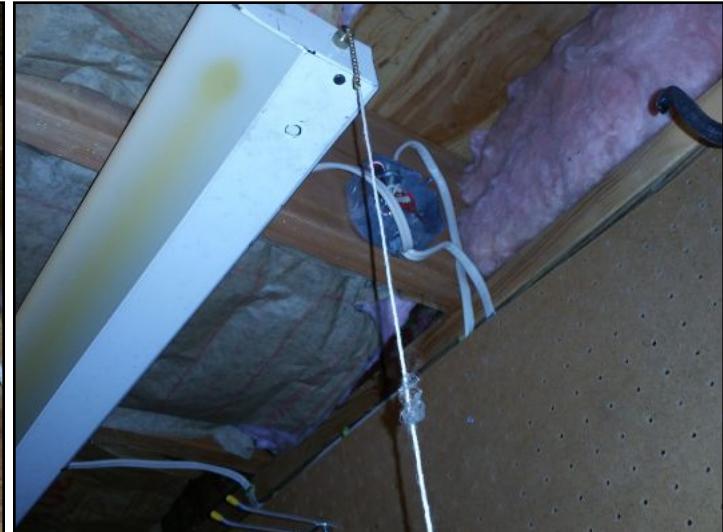
- Romex wiring noted.
- Junction boxes need covers in the front of the garage and in the basement hatchway room.
- **Electrical connections made outside of a junction box in the basement hatchway room.**  
Recommend a licensed electrician evaluate and repair.

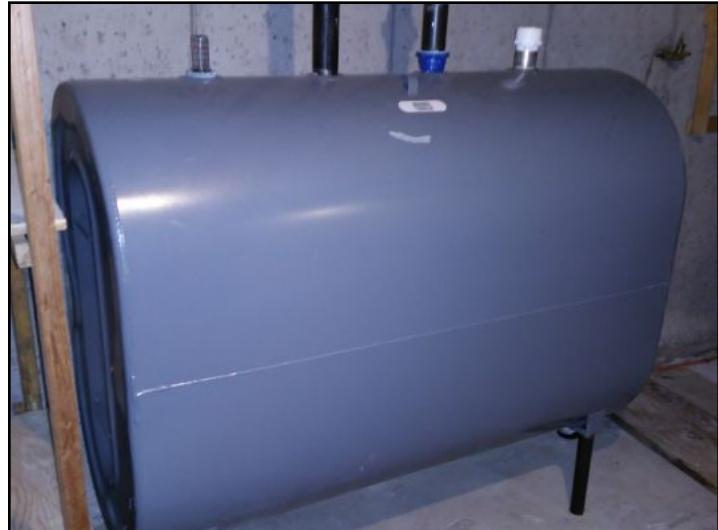
- **Extraneous piping noted going through the foundation wall to the outside, a possible indication of a buried oil tank. Underground tank leaks, environmental damage, local water or well contamination, and a costly cleanup are potential risks associated with buried oil tanks. Recommend confirming whether or not a buried oil tank was present and, if so, that it has been properly removed or abandoned in place.**

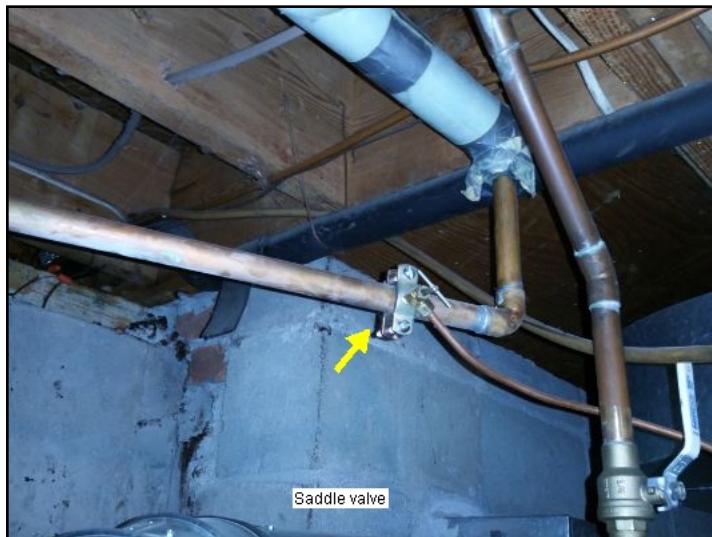
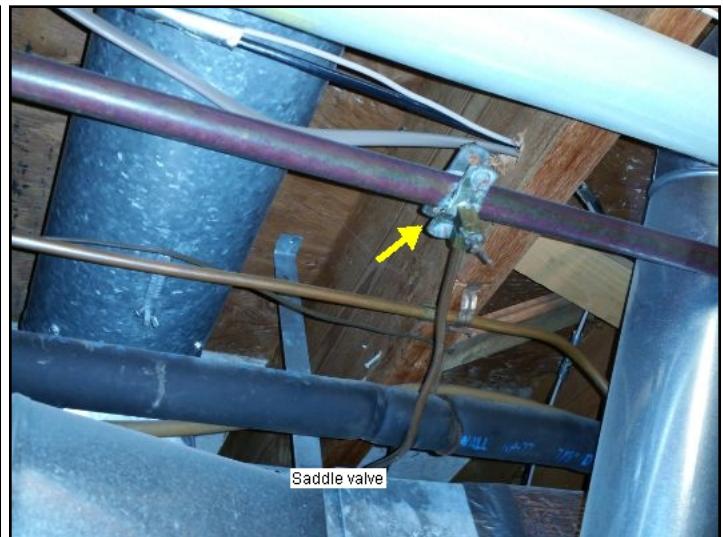
- Copper distribution pipes noted.
- No active leaking was observed.
- Saddle valves were noted near the furnace and in the crawlspace roughly under the kitchen. Saddle valves puncture the plumbing line they are attached to and seal around the puncture with a gasket. The gaskets are prone to leaking with age. Recommend periodic monitoring and repair/replacement as necessary.
- Recommend adding additional support brackets near the water filter and at the refrigerator supply line to hold the pipes in position.

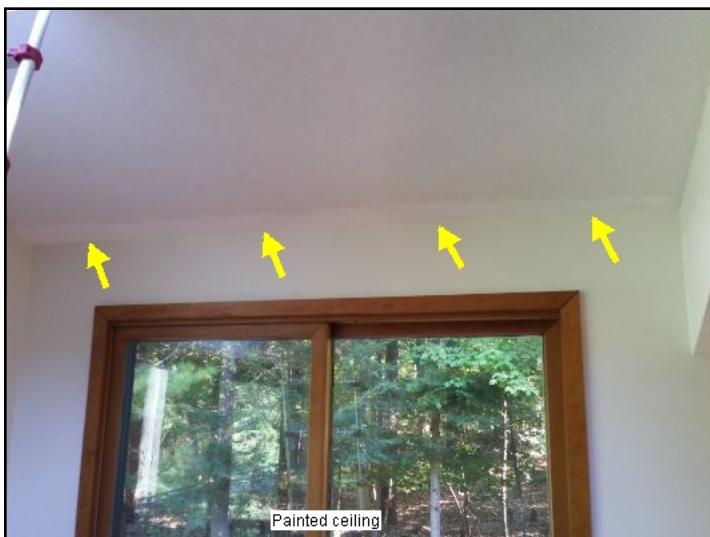
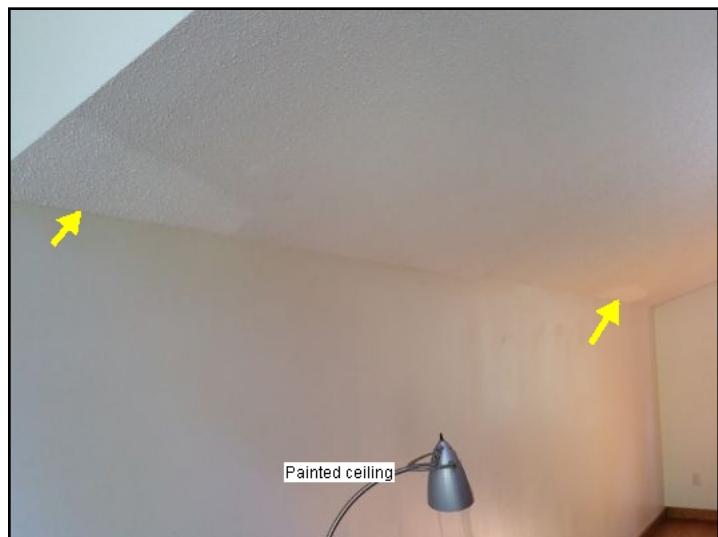
- Painted ceiling noted at the eaves in the living room. This is most likely the result of ice damming. Heat tape was also noted on the roof above.  
**Ice damming is a common issue in which melted snow flows down a roof and re-freezes at the eaves and creates a barrier that traps more melted snow. The water that backs up behind the dam often makes it through the roof covering and can damage ceilings, walls, and structure and promote mold growth. There are many factors that contribute to ice dams, the two largest of which are attic insulation and ventilation. Inadequate insulation/ventilation in the attic makes the attic warmer, which in turn melts more snow, which then turns into ice as it reaches the eaves. A long-term solution to prevent ice dams includes ensuring proper attic insulation and ventilation and air-sealing the space between the ceiling and attic through the use of vapor barriers. Special attention should be drawn to air leak prone areas such as heat registers, recessed lighting, skylights, and other ceiling penetrations. If this is not feasible or practical, other solutions exist such as roof-raking to remove roof snow or the use of heat tape to melt the damming ice.**

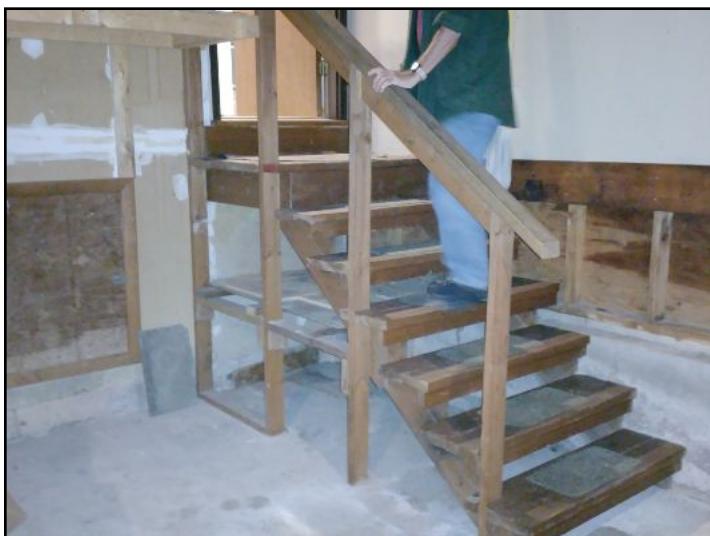
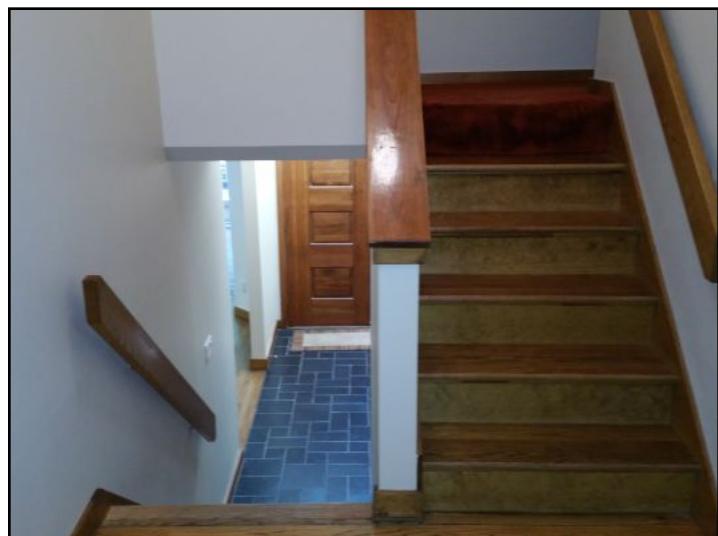
- Handrails and guardrails are secure where present.
- Missing handrail noted at the garage stairs. Recommend installation for safety.

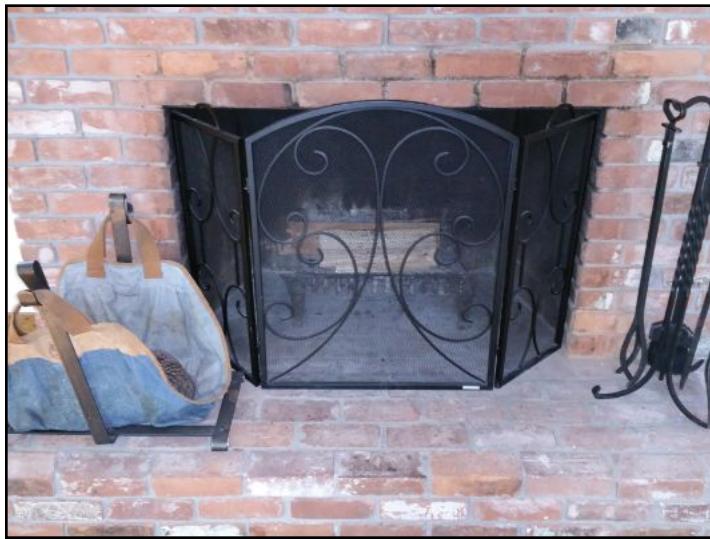
- Heavy soot and/or creosote noted in chimney flue. This is a safety issue as this condition is conducive to chimney fires. Recommend flue be cleaned by a licensed chimney sweep and further inspected to determine its condition.
