# **Intellispect, LLC**

## **Property Inspection Report**

123 Sample Dr, Town, CT 06xxx  
Inspection prepared for: Firstname Lastname  
Date of Inspection: 10/5/2018 Time: 9am  
Age of Home: Built 1978 Size: 2357 sq ft  
Sample Report

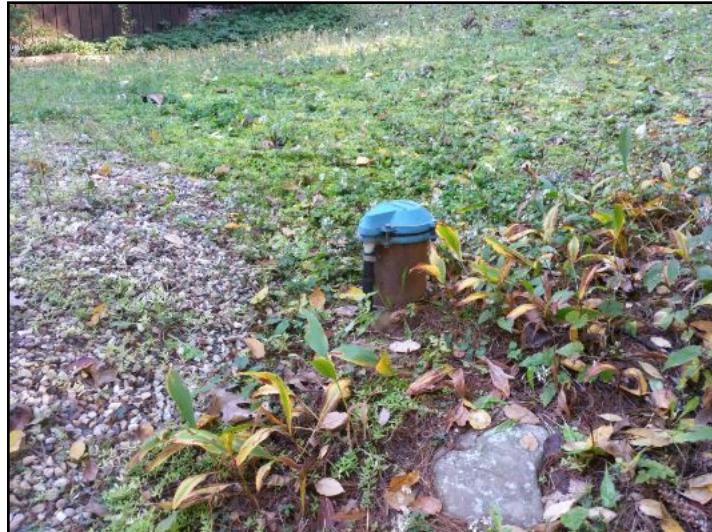
- Well head noted in the front yard toward the east side. You should consider installing a protective housing to prevent mechanical damage.

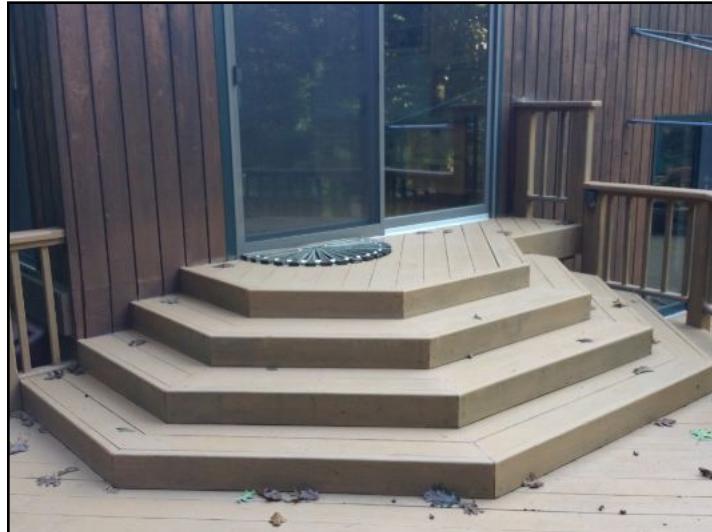
- There were no handrails installed at multiple sets of deck steps. This is a potential safety hazard. 3 or more risers should have a handrail. Recommend installation.
- Deck balusters spaced more than 4 inches apart. Though this may have been acceptable at the time of the original construction, it is now considered a safety concern. Recommend installing balusters spaced such that a 4-inch sphere could not pass through.

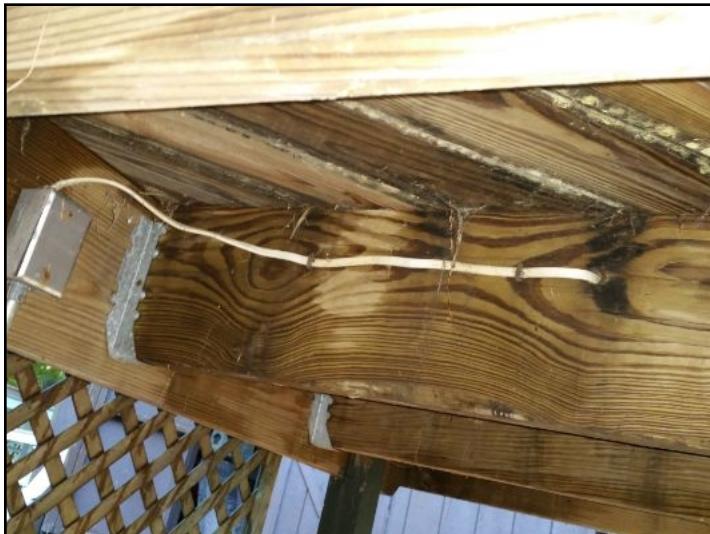
- Exterior conductors under the back deck are not protected by a conduit. One of the electrical cables has worn through its protective sleeve. This is a shock hazard. All exterior wiring should be secured to the home and/or inside an approved conduit. Recommend further evaluation and repair by a qualified electrician.

Sleeve has worn through

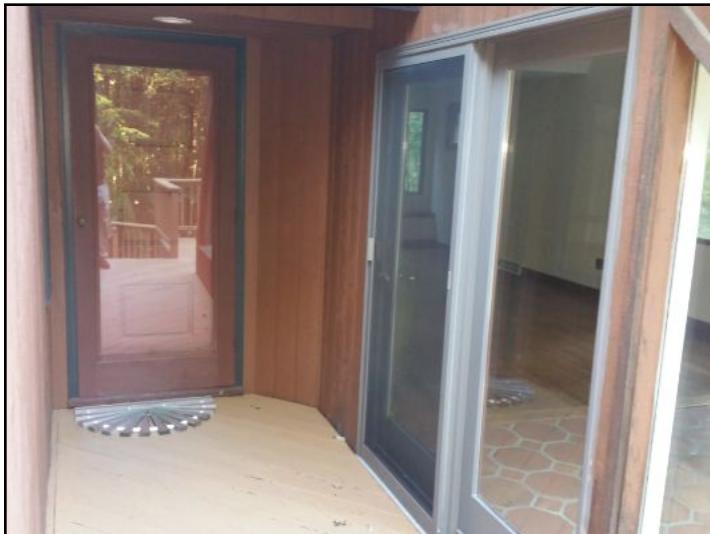
- Exterior doors noted in front of the garage, at the front deck (2), on the east side, and at the back deck.
- Appeared in functional and in satisfactory condition at time of inspection with no major deficiencies noted except for the following:
  - Doorbell tested and functioning at the time of inspection.
  - **Exterior door on the east is at an unsafe level above grade. This condition may cause someone to get hurt if they fall out of the doorway. Recommend installing a platform for safety or rendering this door unusable.**

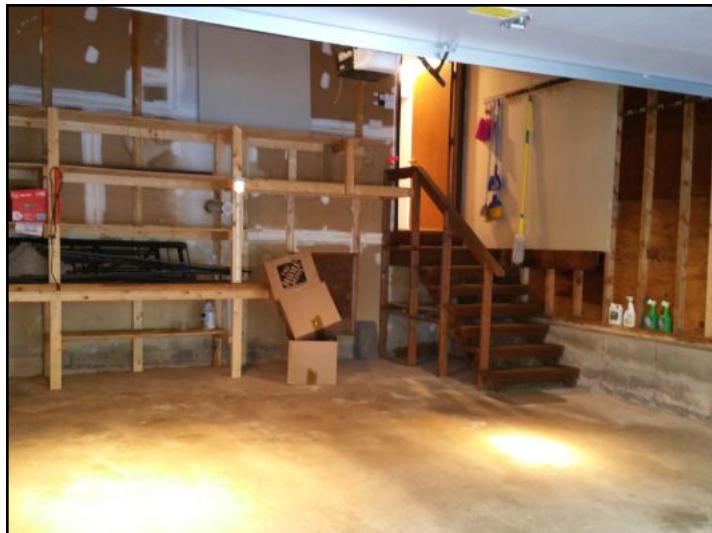
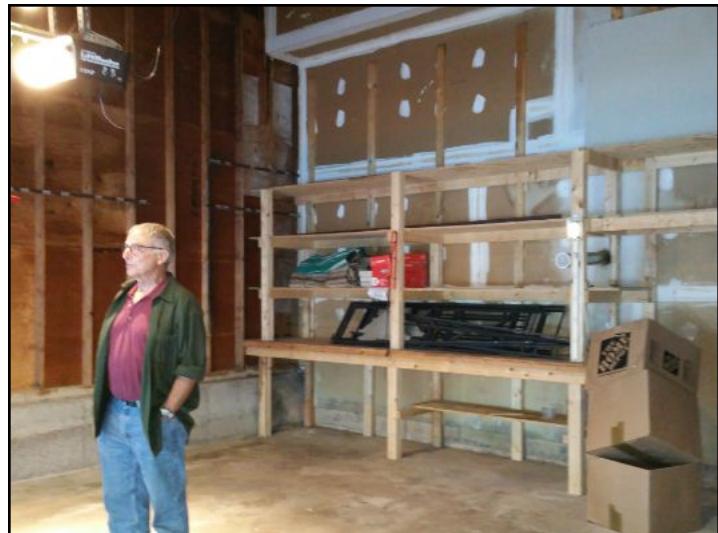
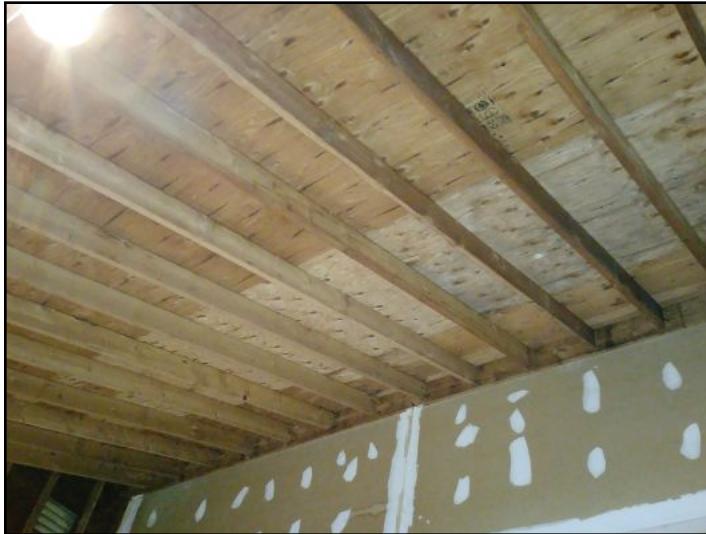
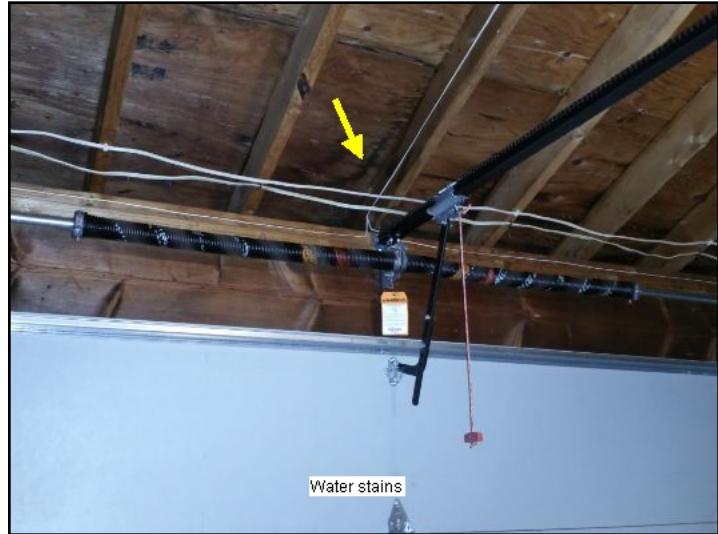
- Stud walls noted.
- Bare concrete floors noted.
- Rafter construction noted. 2x6 dimensional lumber, 16" on center.
- Plywood sheathing noted.
- No evidence of bowing, cracking, or sagging of the structural members; They were all straight and even.
- Water stains were noted on the rafter above the overhead door, indicative of a past leak. Though the area tested dry at the time of the inspection, I cannot predict that it won't leak in the future. Recommend asking the seller about any repairs that had been made and monitoring the area for future leaks.

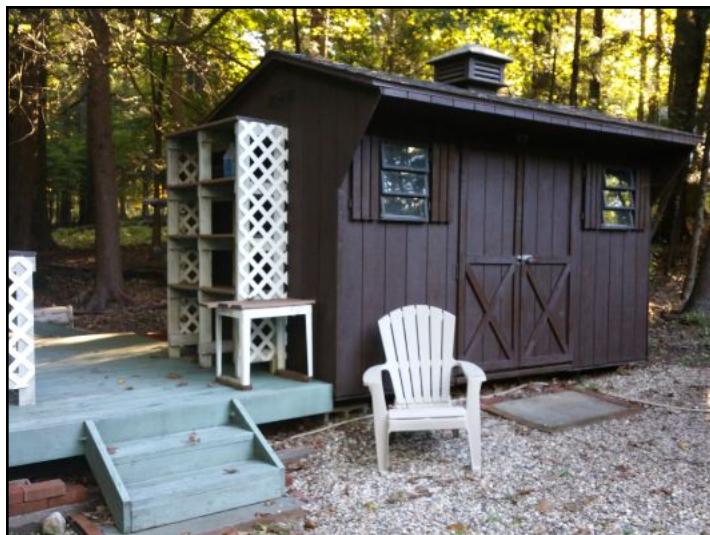
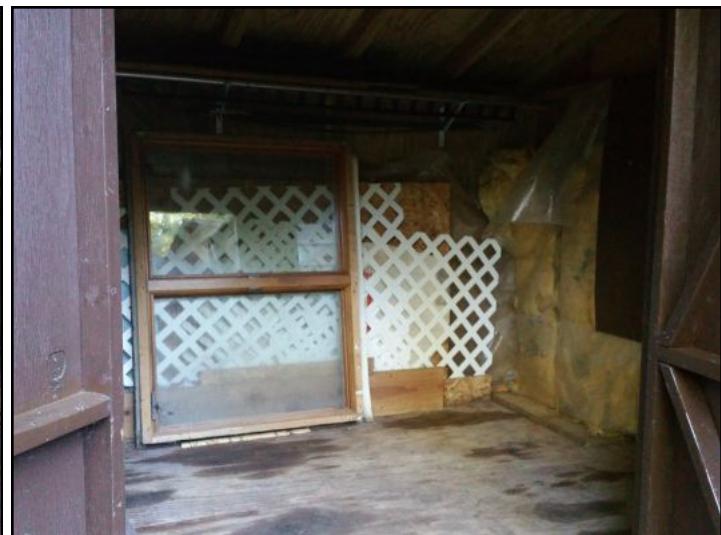
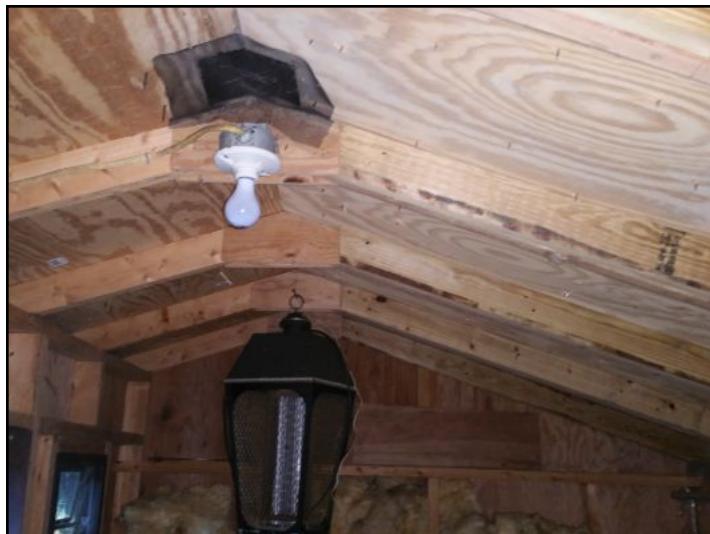
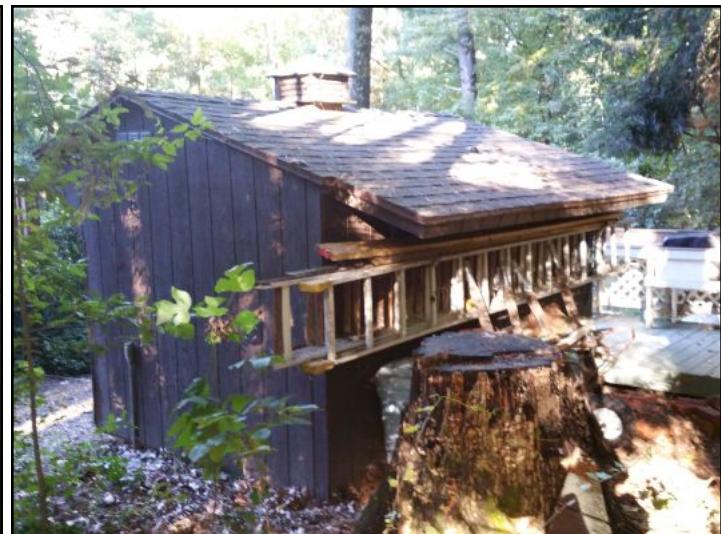
- Shed noted on the east side yard.
- Wood rafters noted, 2x4 dimensional lumber, 24" on center.
- Plywood sheathing noted.
- No water stains observed on the roof structure.
- No bowing, sagging, or cracking observed on any of the structural members.
- A musty odor was noted in the shed and water stains were present on the floor, suggesting moisture is getting in. Recommend keeping the area around the perimeter of the shed free of debris that will hold moisture against the shed and help prevent insect infestations.

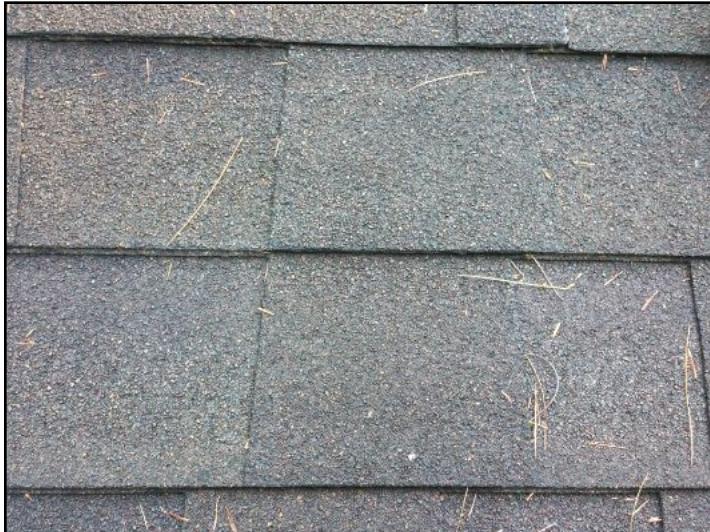
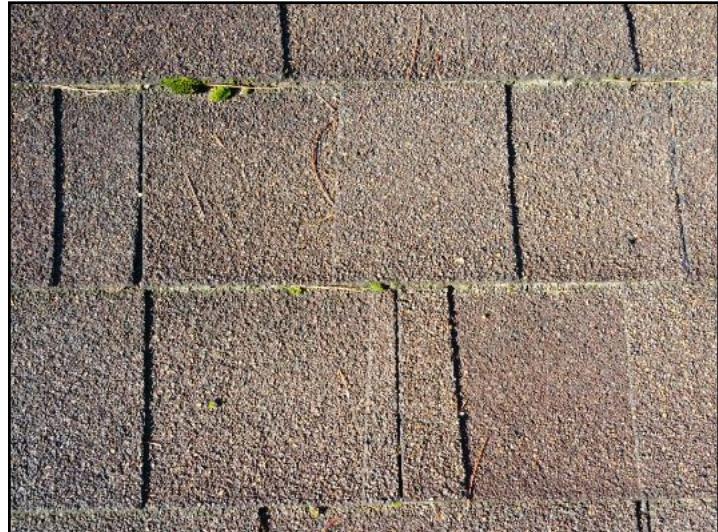
- Roof appears to be in the first third of its useful life.
- The areas above the main entrance and under the overhang on the east side roof are shaped such that it will take longer to dry and tend to collect debris which will hold moisture against the roof and cause premature aging. Recommend keeping this area clear.

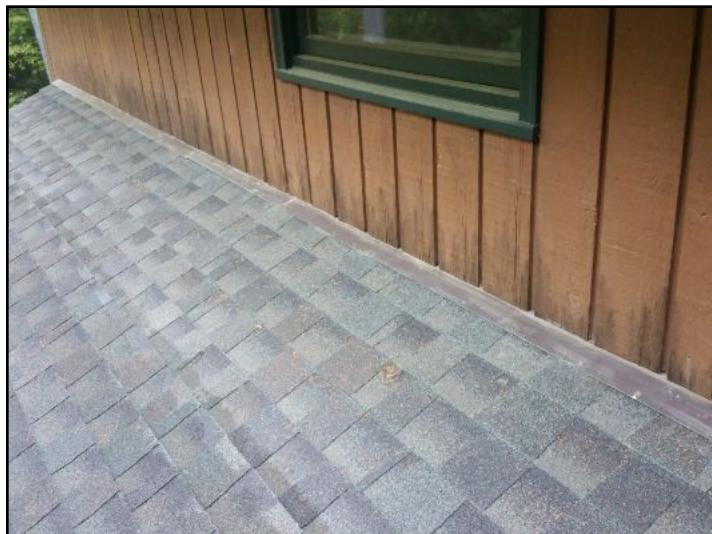
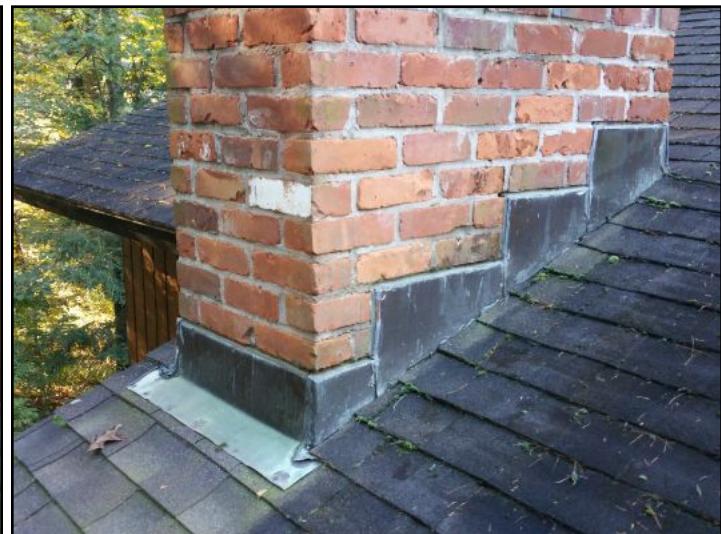
- Metal flashing visible around chimney.
- Metal apron flashing visible.
- Drip edge flashing noted.
- Sidewall flashing noted.
- Fastener heads are visible at the chimney flashing. Recommend sealing over the top of all fasteners that penetrate through the roof to prevent moisture intrusion.

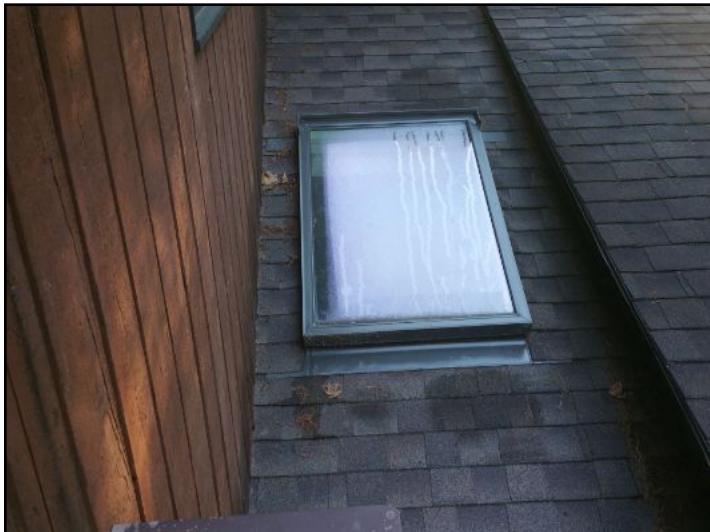
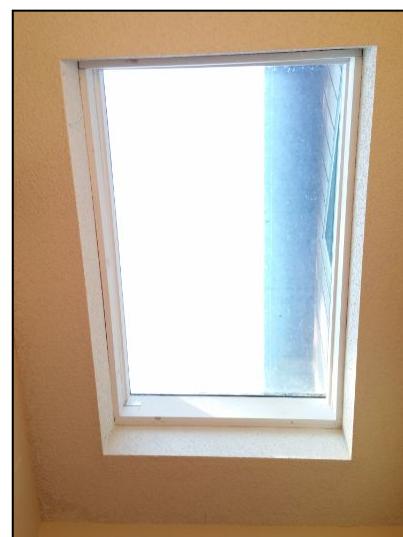
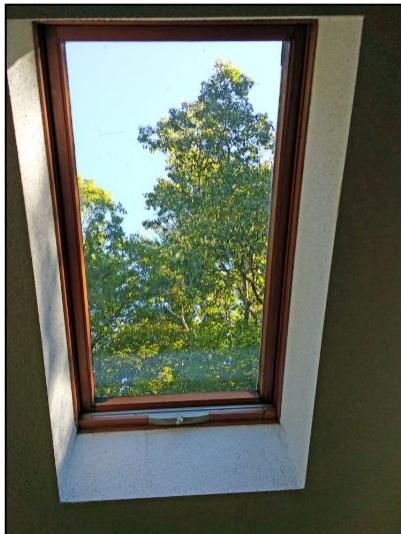
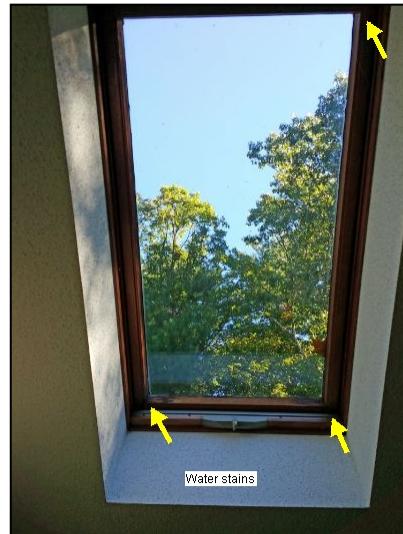
- Skylights noted above the main entryway and on the east facing roof plane (x2).
- Recommend clearing the area above the entryway skylight free of debris.
- Fastener heads are visible at the flashing at both east side skylights. Recommend sealing over the top of all fasteners that penetrate through the roof to prevent moisture intrusion.
- The two skylights on the east side have water stains at the corners that tested positive for moisture content, indicating leaks. Recommend further evaluation and repair or replacement of the skylight flashing as necessary by a qualified roofing contractor.

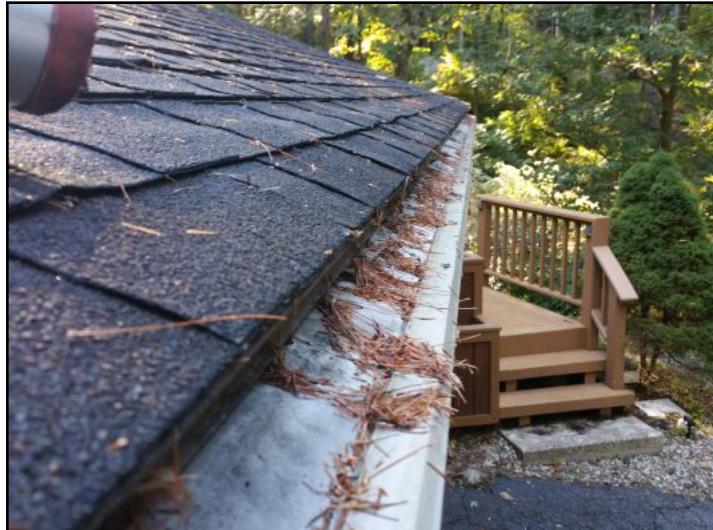
Missing gutters

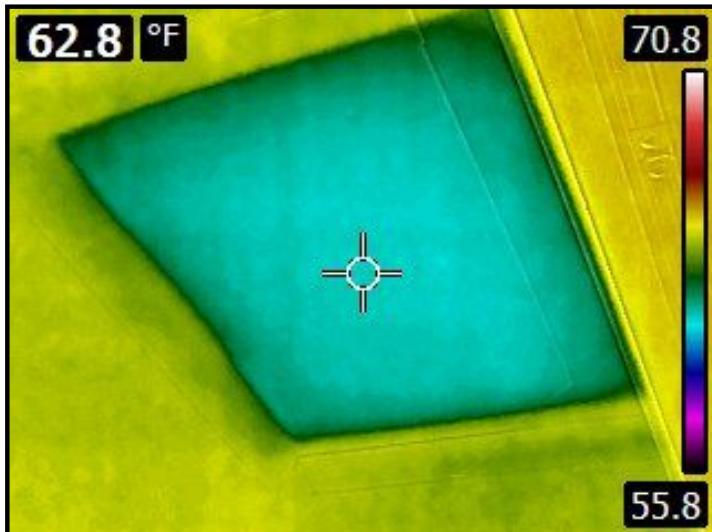
Infrared imaging suggests the attic access is a big source of heat loss. You should consider insulating the area above/behind the attic access.

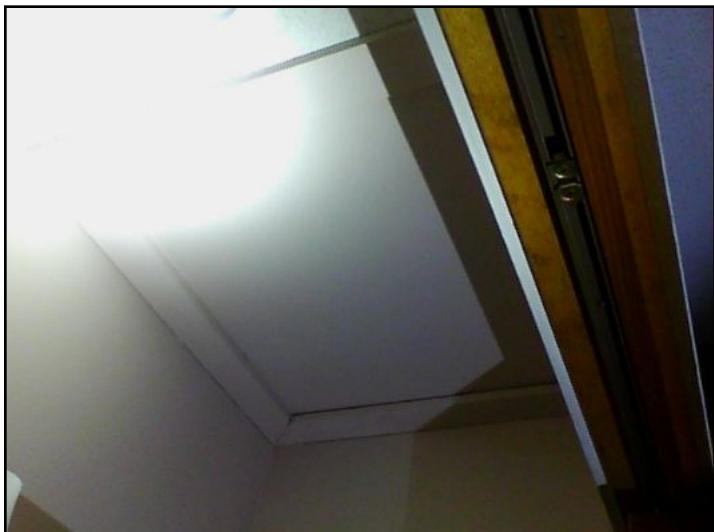
Plain camera view of the previous photo.

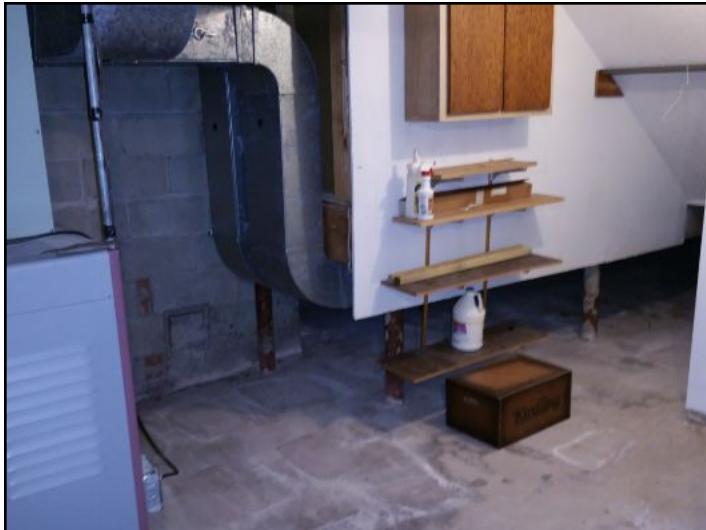
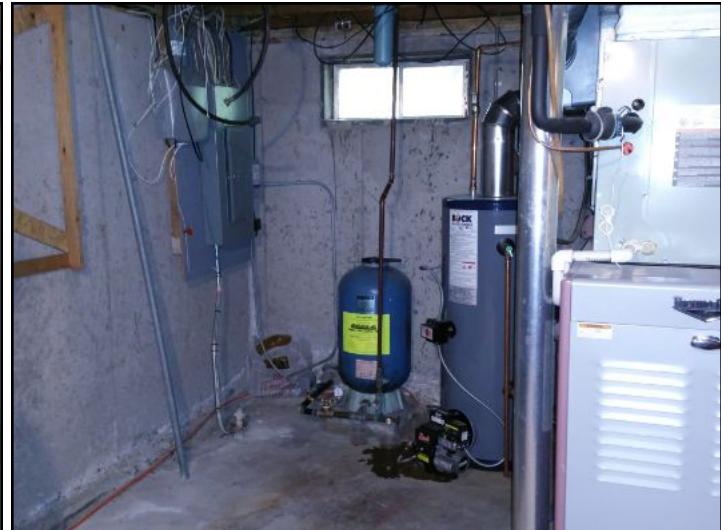
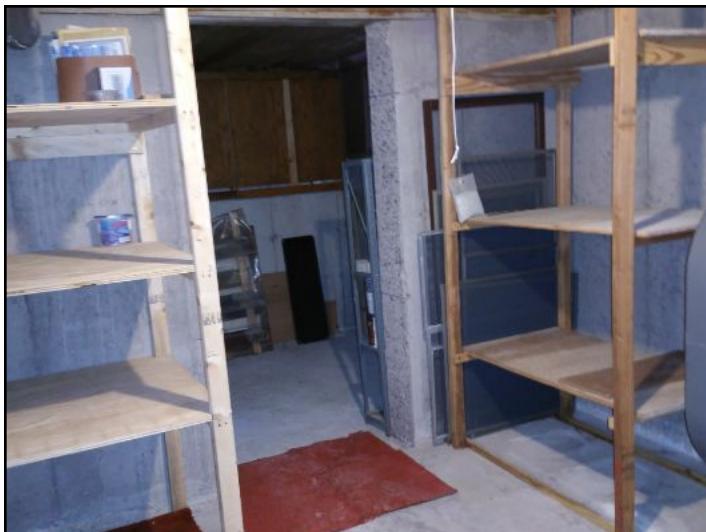
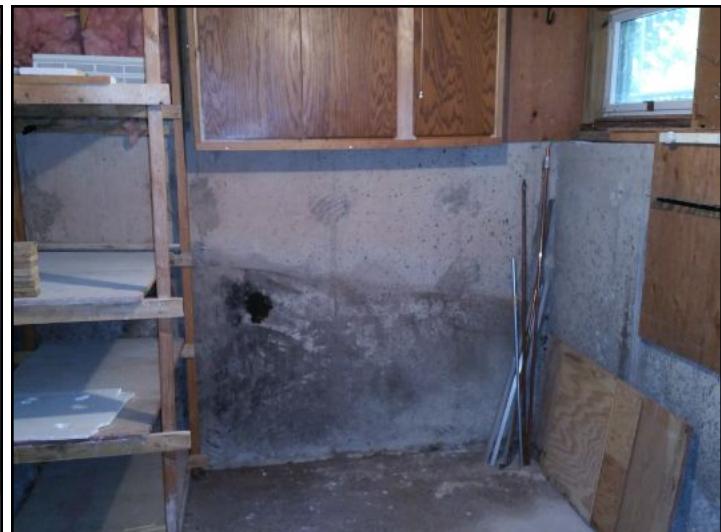
- Indications of mice were noted in the basement and crawlspace. This is a common issue, especially in vacant homes. Use store bought products and contact a pest control company if the problem persists.

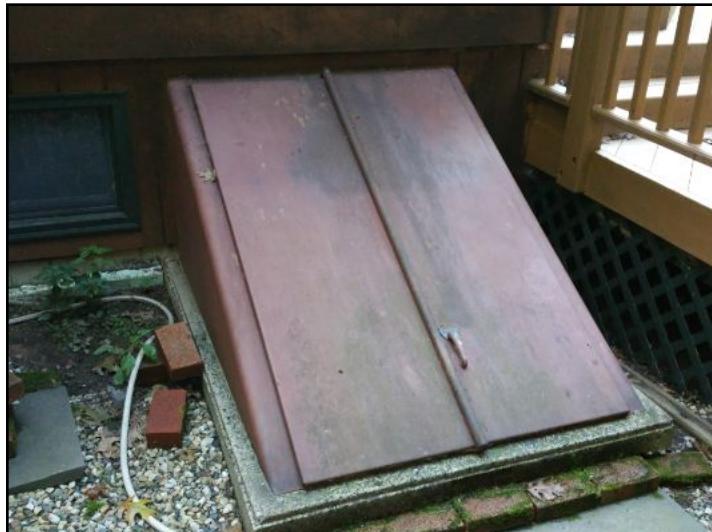
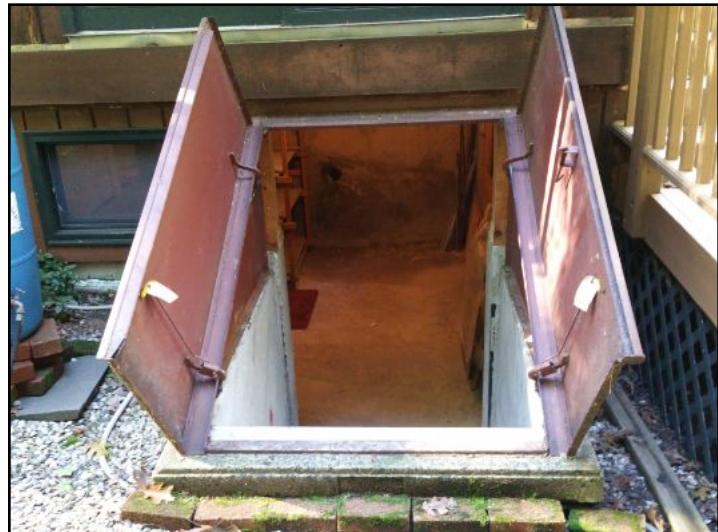
- Exterior hatch door present.
- Exterior door opened and closed with no issues.
- Gaps noted between the hatch door and the house which may allow moisture to get in. Monitor the area and seal these gaps as necessary.
- No major deficiencies observed.

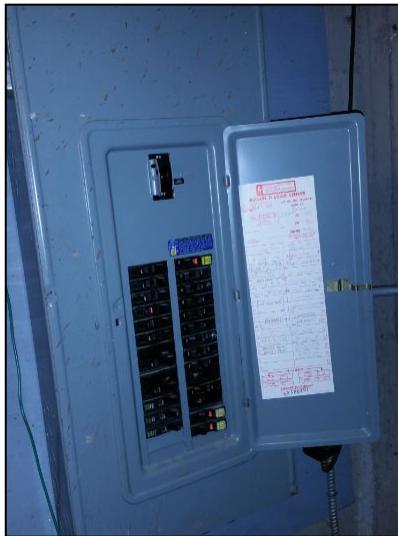
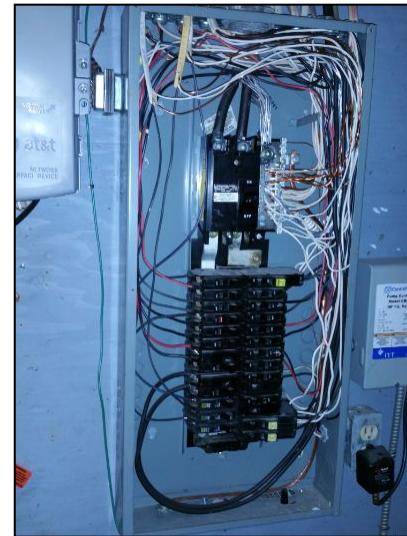
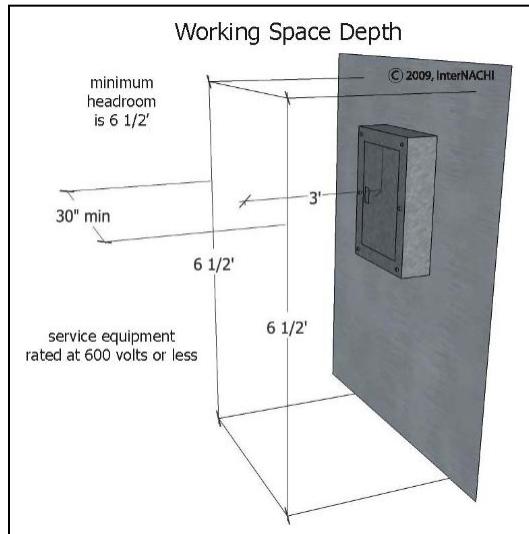
- Branch wires appear to be sized proportionally to the amperage of the breaker.
- GFCI breakers noted and tested functional.
- Panel has inadequate clearance. The area 30" wide, 78" high, and 36" deep should be free of obstructions.

- Double tapping and lugging can create hot spots on breakers and neutral bars because they are not tightened to the correct torque - especially if two different size conductors are used. If the double tap or lug becomes loose, it begins to arc. As it arcs it builds up carbon. Carbon is then resistance and with more carbon buildup the more difficult it is for the conductor to make contact, thus increasing the current. The end result can be melted wires or even fire.

- **Double tapped breakers (x3) inside the panel box (more than one electrical conductor attached).** Recommend evaluation and repair by a licensed electrician.

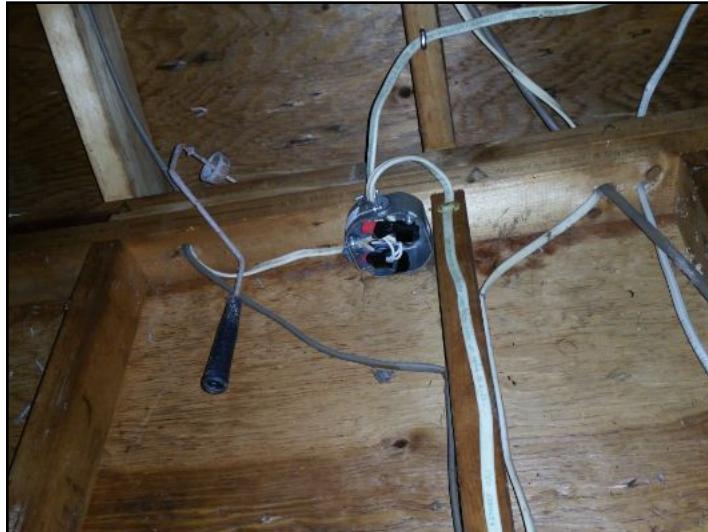
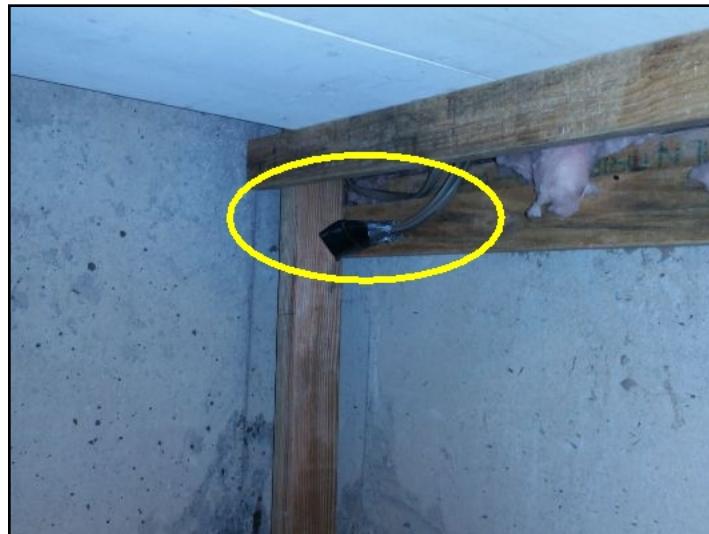
- Romex wiring noted.
- Junction boxes need covers in the front of the garage and in the basement hatchway room.
- **Electrical connections made outside of a junction box in the basement hatchway room.**  
Recommend a licensed electrician evaluate and repair.

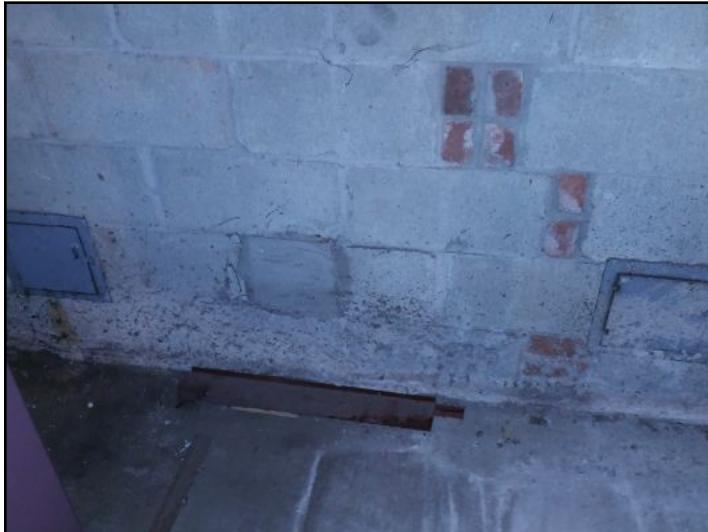
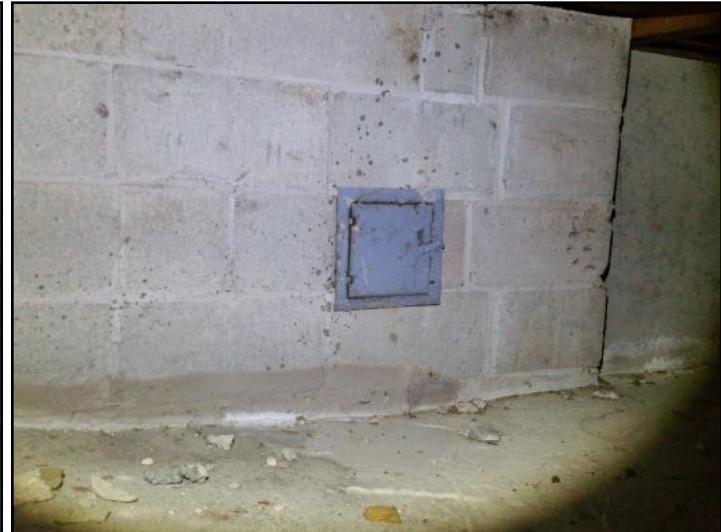
## 6. Chimney Cleanout

- Locations: At the base of the chimney in the basement (x3).
- Recommend periodic monitoring of the ash level and cleaning as necessary.

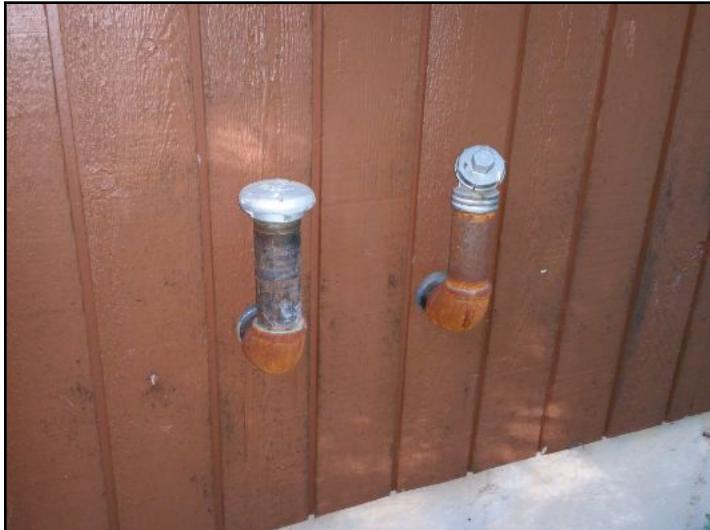
- **Extraneous piping noted going through the foundation wall to the outside, a possible indication of a buried oil tank. Underground tank leaks, environmental damage, local water or well contamination, and a costly cleanup are potential risks associated with buried oil tanks. Recommend confirming whether or not a buried oil tank was present and, if so, that it has been properly removed or abandoned in place.**

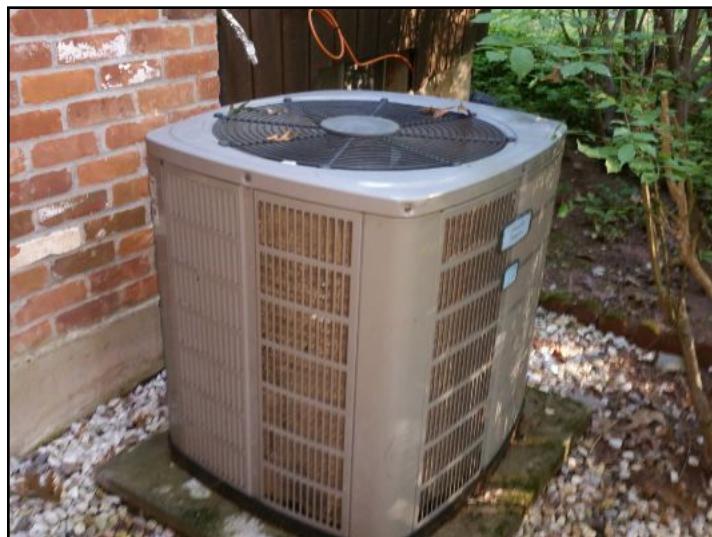
## 8. Cooling

- Electric air conditioning compressor is located at the southeast exterior.
- Functioning properly at the time of inspection.
- The typical temperature differential between supply and return air in an air conditioner of this type is 12 - 18 degrees F. This system responded and achieved an acceptable differential temperature.
- Air conditioning mounting pad was level.
- Refrigerant line is insulated.
- No major deficiencies observed.
- Data plate indicates unit is a American Standard. According to the U.S. Consumer Product Safety Commission's website ([www.cpsc.gov](http://www.cpsc.gov)), there are no recalls or safety bulletins regarding this appliance.
- According to the data plate/serial number, this unit was manufactured in 2007. Recommend a service technician verify this date. Typical lifespan is 12 to 15 years.

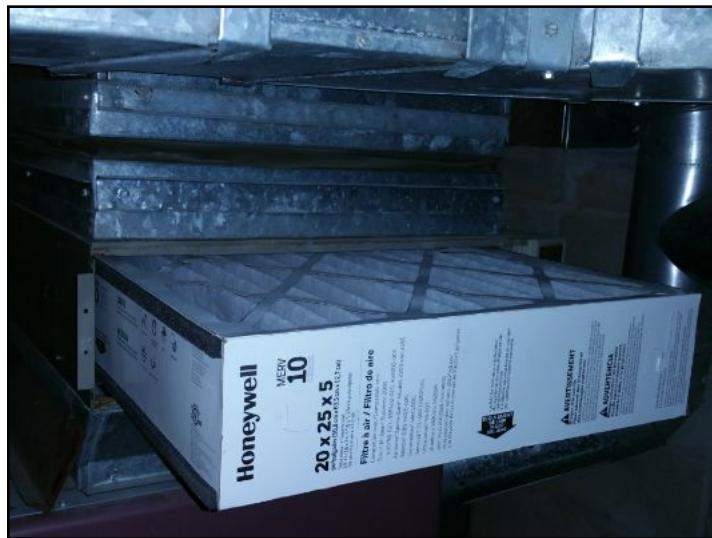
## 12. Filters

- Disposable filter noted at the furnace return duct.
- Appears clean and functional.
- Forced air furnaces and central air systems have a filter that need to be cleaned or changed regularly. The time period varies by model. It is estimated that up to half of all furnace related service calls are due to dirty filters. Be advised most filters need to be oriented correctly for best performance. Watch for an "air flow" direction arrow on the filter. This arrow usually points toward the furnace when installed.
- Recommend at least monthly checking of the air filter and cleaning or replacing air filters according to manufacturer's specifications.

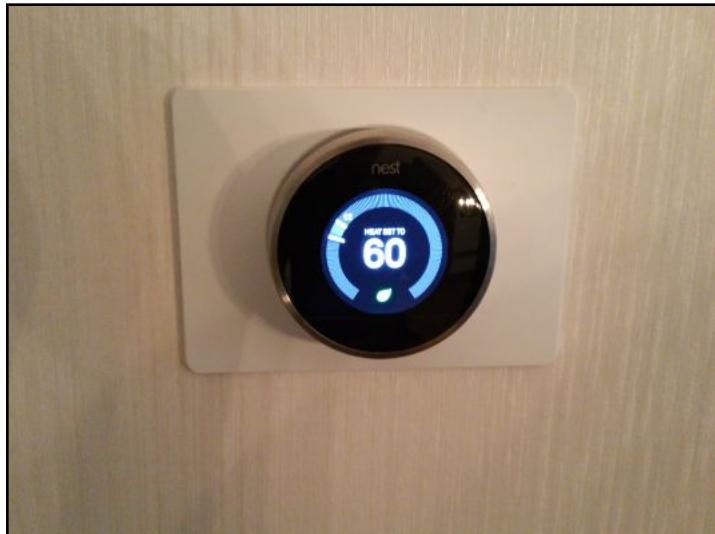
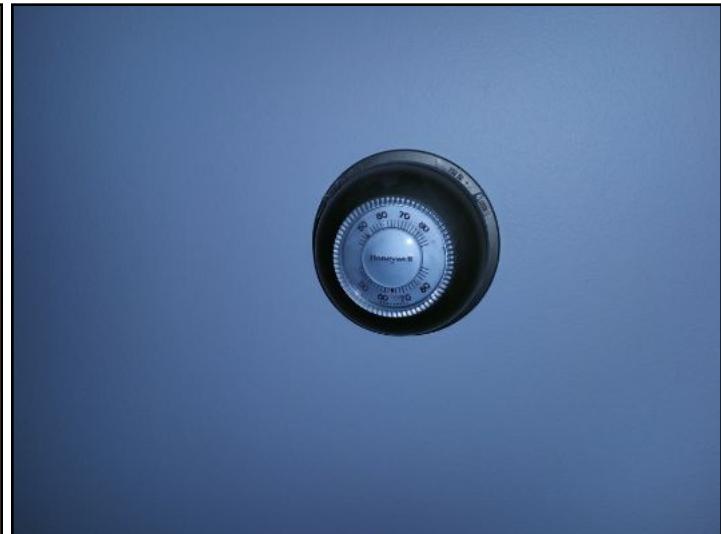
## 13. Thermostats

- Thermostats located in the dining room (for heat only) and master bedroom (for cooling only).
- Functional at the time of inspection.
- With multiple thermostats that control both heating and cooling, care should be exercised so as to not run both the heating and cooling systems at the same time. This may result in damage to one or both systems.

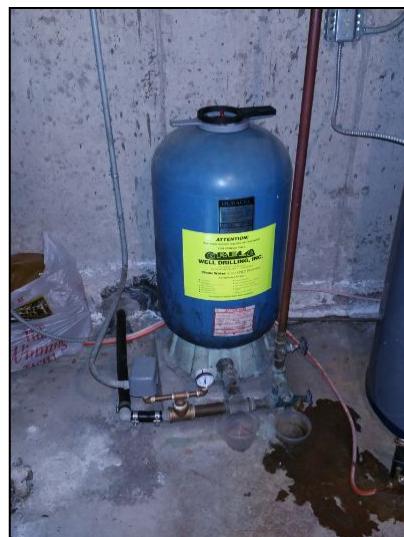
## 1. Supply

- Rubber/plastic supply line noted.
- Emergency water shutoff valve is located at the well supply. You should know where it is in case of an emergency.
- Appeared functional at time of inspection.

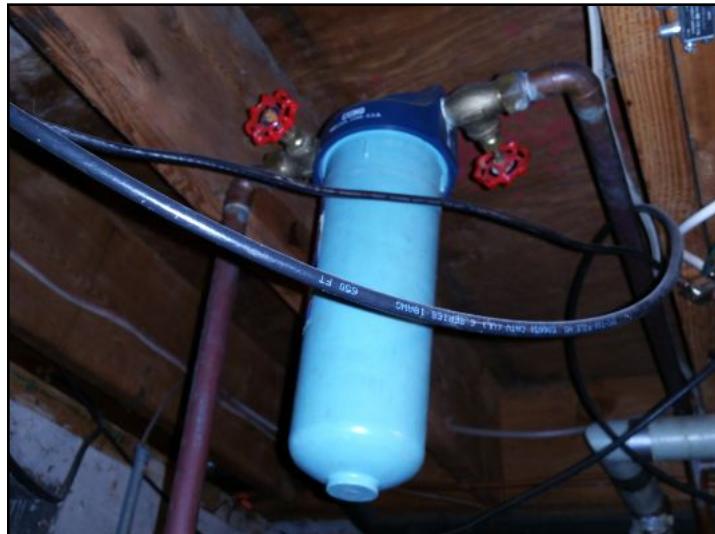
## 3. Water Treatment

- Water filter noted above the storage tank. Recommend maintenance according to manufacturer's recommendations which includes periodic changing of the filters.

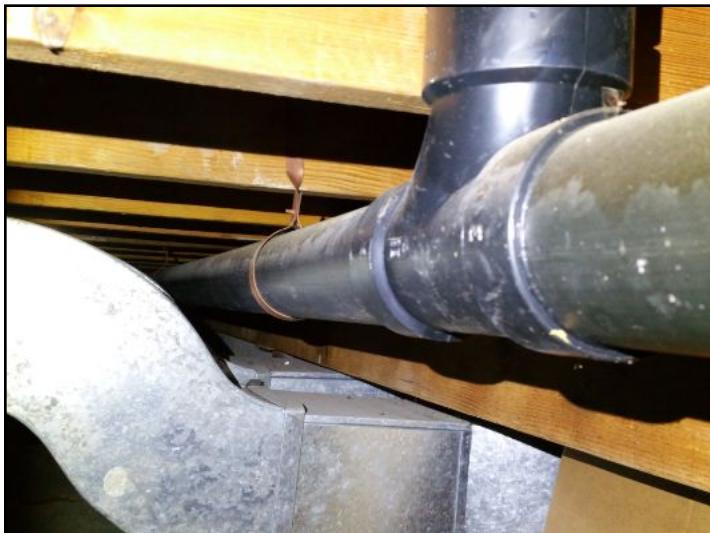
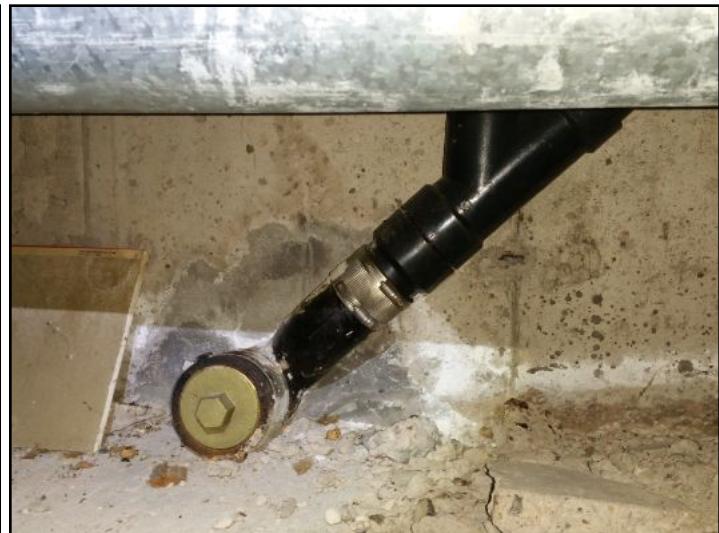
## 6. Waste

- Acrylonitrile-Butadiene-Styrene (ABS) waste and vent pipes noted.
- Septic system noted and is beyond the scope of a home inspection. Recommend seeking the services of a specialist in cleaning and evaluating this system prior to closing.
- After flushing toilets and running water from sinks, bathtubs, and showers, no active leaking was observed in any of the visible waste pipes.

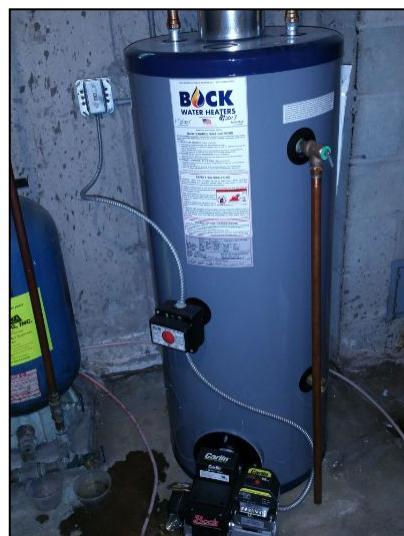
- Data plate indicates the unit is a Bock model 32E. According to the U.S. Consumer Product Safety Commission's website ([www.cpsc.gov](http://www.cpsc.gov)), there are no recalls or safety bulletins regarding this appliance.

- According to the data plate/serial number lookup, this unit was manufactured in 2017. Recommend a service technician verify this date. Typical lifespan is 8 to 12 years.

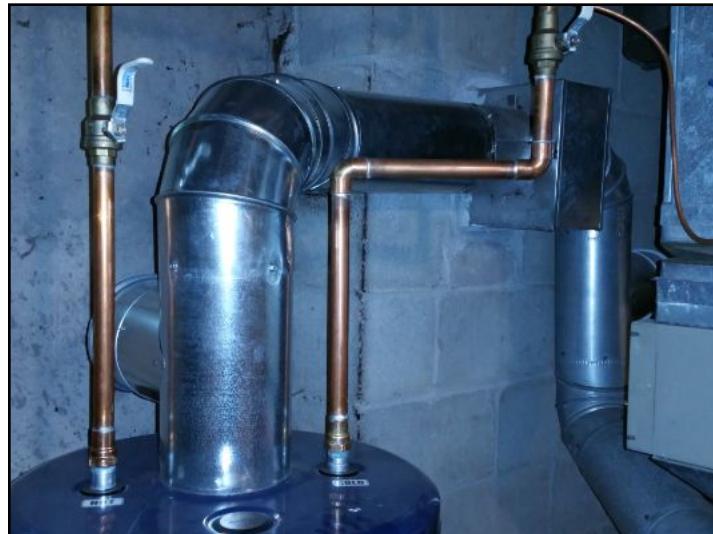
## 4. Exhaust

- Metal wall chimney exhaust pipe noted.
- Barometric damper present and appears functional.
- The hot water tank shares an exhaust port with the furnace.
- No major deficiencies noted at the time of inspection.

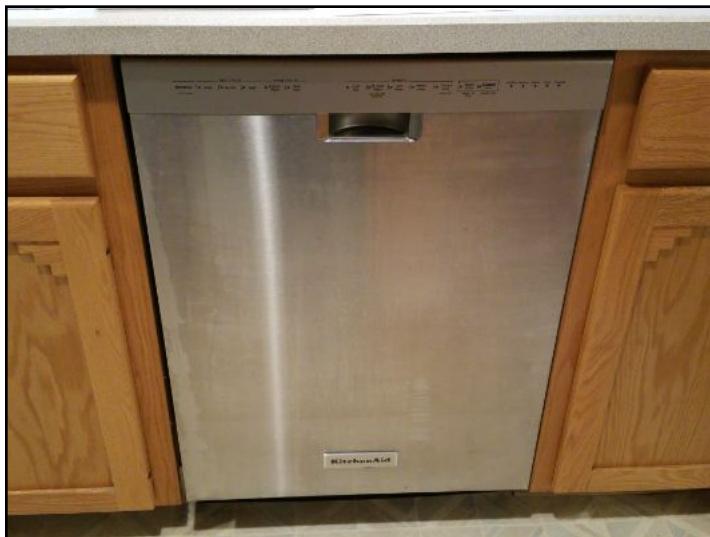
## 6. Dishwasher

- Functioned normally during the inspection.
- Gasket appeared to be in good condition.
- No leaking observed.
- Dishwasher is a KitchenAid model KDFE104DSS3. According to the U.S. Consumer Product Safety Commission's website ([www.cpsc.gov](http://www.cpsc.gov)), there are no recalls or safety bulletins regarding this appliance.
- According to the data plate/serial number lookup, the dishwasher was manufactured in 2016. Average lifespan is 8 to 15 years.

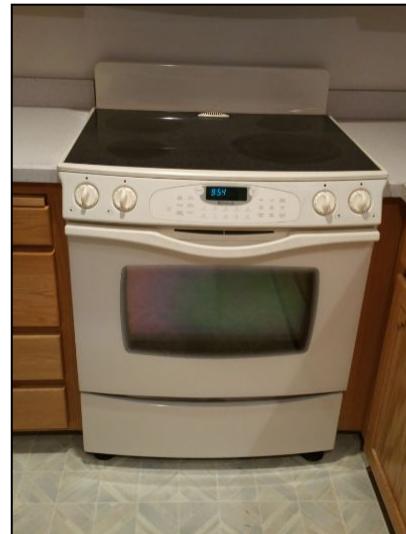
## 7. Range/Cook Top

- Electric cook top noted.
- All heating elements operated when tested.
- Anti-tip bracket is missing from range installation. All free-standing, slide-in ranges include an anti-tip device and is essential in the safe operation of the range. It provides protection when excess force or weight is applied to an open oven door. Recommend installation for safety.
- Cook top is a Maytag model JES8850AAQ. According to the U.S. Consumer Product Safety Commission's website ([www.cpsc.gov](http://www.cpsc.gov)), there are no recalls or safety bulletins regarding this appliance.
- According to the data plate/serial number lookup, the cook top was manufactured in 2004. Average lifespan is 10 to 20 years.

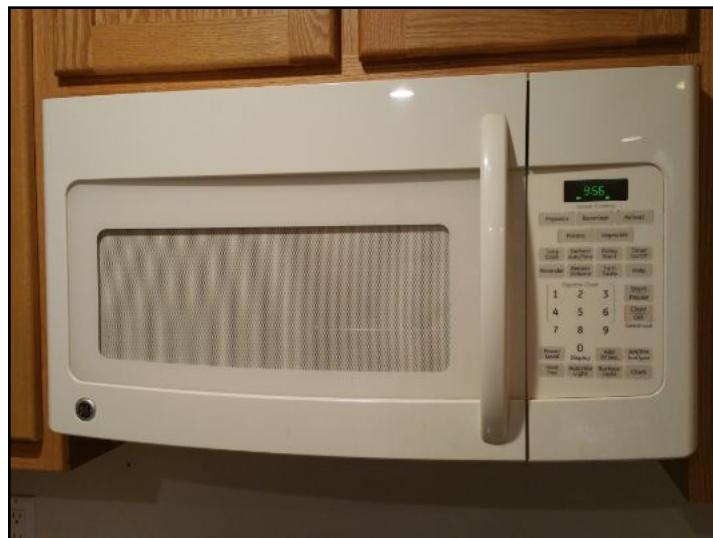
## 9. Microwave

- Functioned properly during the inspection.
- Microwave is a GE model JVM1750DP2CC. According to the U.S. Consumer Product Safety Commission's website ([www.cpsc.gov](http://www.cpsc.gov)), there are no recalls or safety bulletins regarding this appliance.
- According to the data plate/serial number lookup, the microwave oven was manufactured in 2012. Average lifespan is 5 to 10 years.

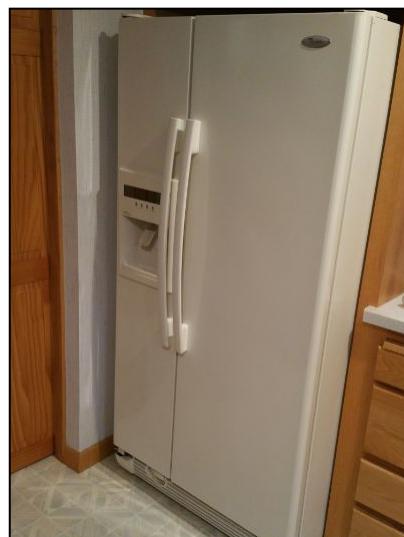
## 10. Refrigerator & Freezer

- Refrigerator and freezer were functioning at the time of inspection.
- Water and ice dispenser features noted.
- Water and ice dispenser features were tested and functional at the time of inspection.
- Water dispensers often go unused for long periods of time, resulting in a stale or metallic taste from water that has been sitting in the line for too long. Flushing the water periodically should resolve this issue.
- Gaskets noted to be in good condition.
- Refrigerator/freezer is a Whirlpool model ED2KHAXVT01. According to the U.S. Consumer Product Safety Commission's website ([www.cpsc.gov](http://www.cpsc.gov)), there are no recalls or safety bulletins regarding this appliance.
- According to the data plate/serial number lookup, the refrigerator was manufactured in 2010. Average lifespan is 10 to 20 years.

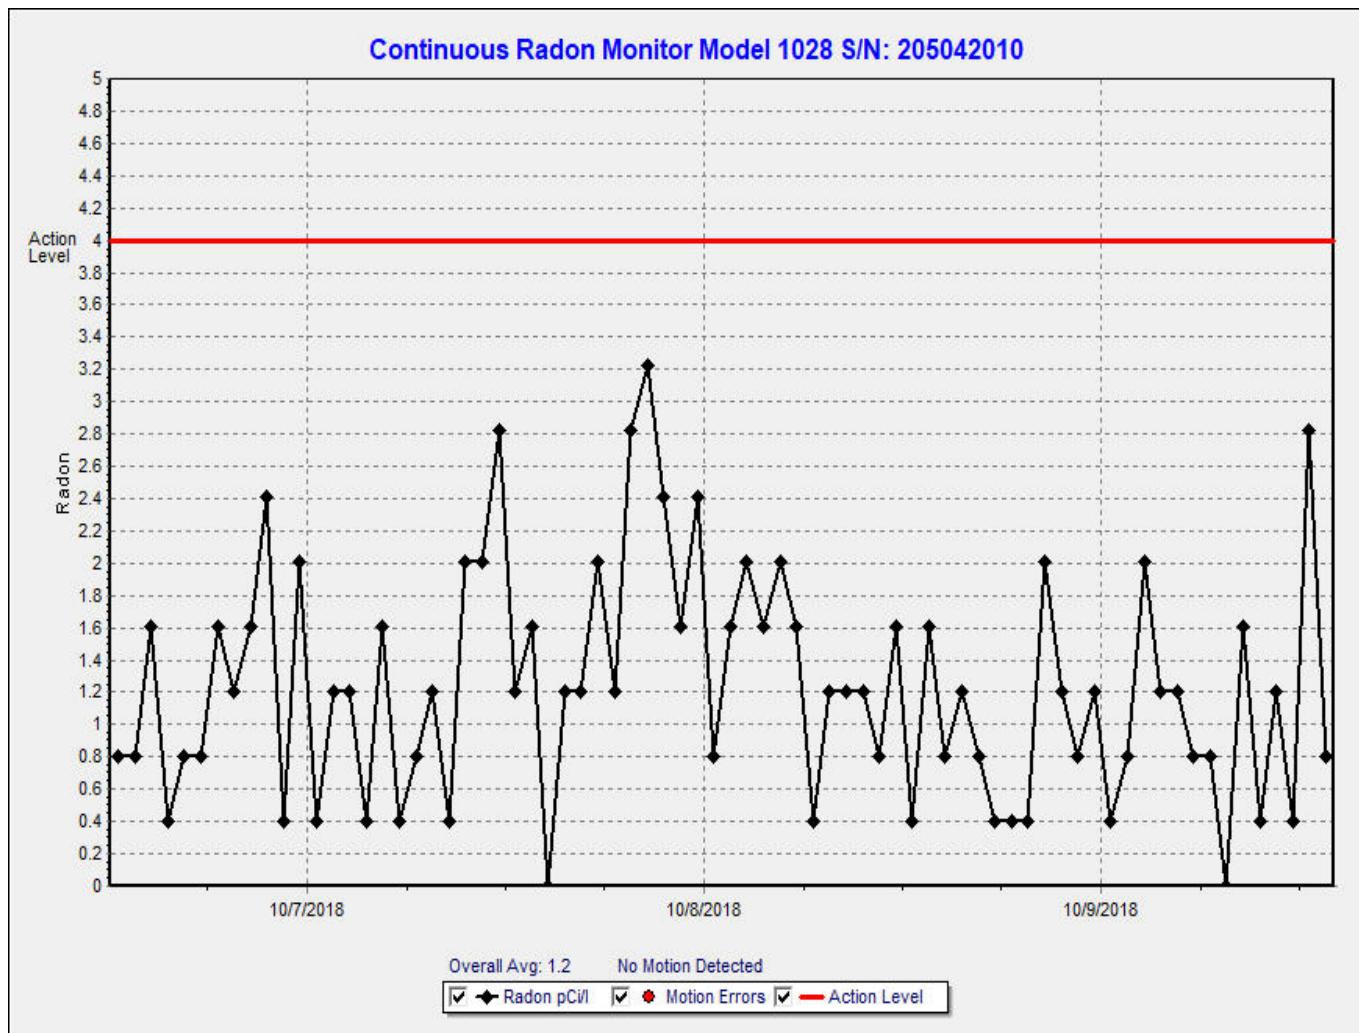
- Radon levels were tested using a tamper-resistant continuous monitor located in the basement. This test is a 48-hour minimum test that started at 1pm on October 6th and ended at 2pm on October 9th, 2018. The average radon level was 1.2 pCi/L, and the full results are shown in the above graph.

- Based on your average radon levels, no action is recommended at this time.
